Safety Alert

Alert 2013-11

Installing Flowline

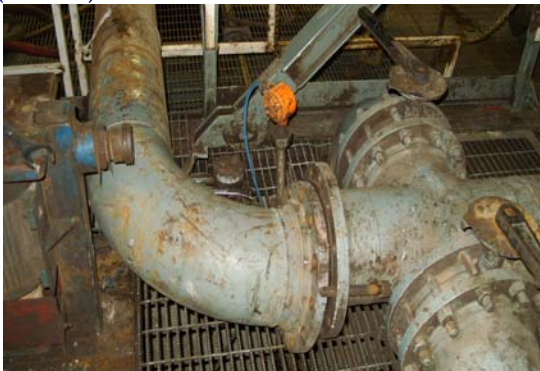
(Before)

The rig was in the process of rigging-up after a rig move. The injured employee was on top of the trip tank with (2) others attempting to line up the 90 degree elbow with the connecting flange. While lining it up, this flowline elbow turned pinching fingertip of employee's right ring finger. This "pinch" resulted in a fracture and stitches to the finger.

- Improper position for task
- Congestion or restricted action
- Failure to identify hazard/risk (i.e. "What can hurt me?")
- Infrequent task. (The employee's work schedule didn't coincide with previous rig moves)
- Rig-up prohibited use of forklift in this area

- Develop a rig-specific JSA
- Distribute a Safety Alert to all rigs of the incident
- Weld handles on flow line to keep hands out of the "line-of-fire"
- Take additional time to communicate pre-job procedure BEFORE work begins
- Pre-plan job to use mechanical assistance. (forklift)
